**Naval Surface Warfare Center
Carderock Division**

NSWCCD-TR-65-97/18 April 1997

**An Experimental Investigation of the Ultimate
Strength of Stiffened Panels**

- Volume 1, Results and Analyses

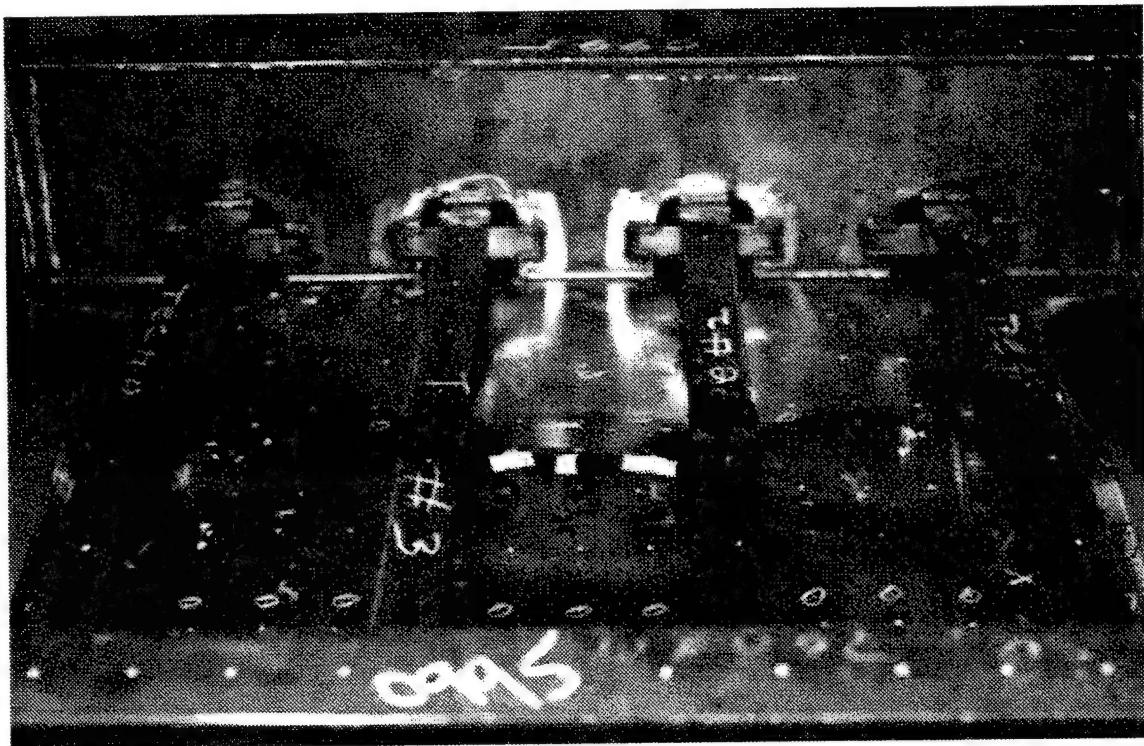
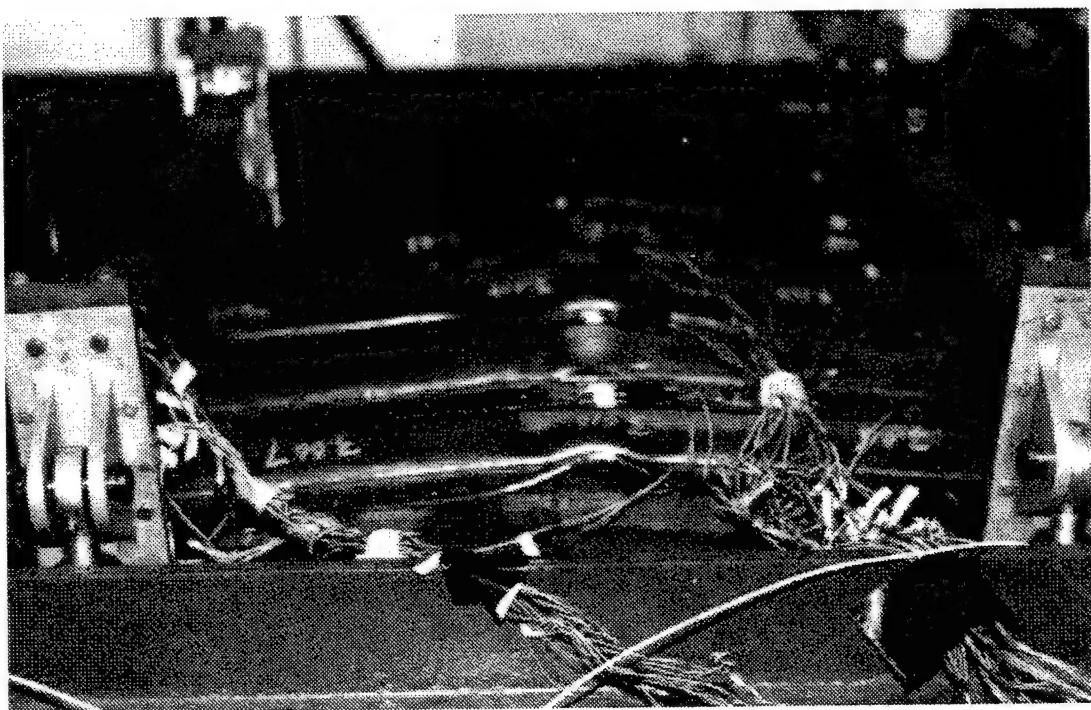
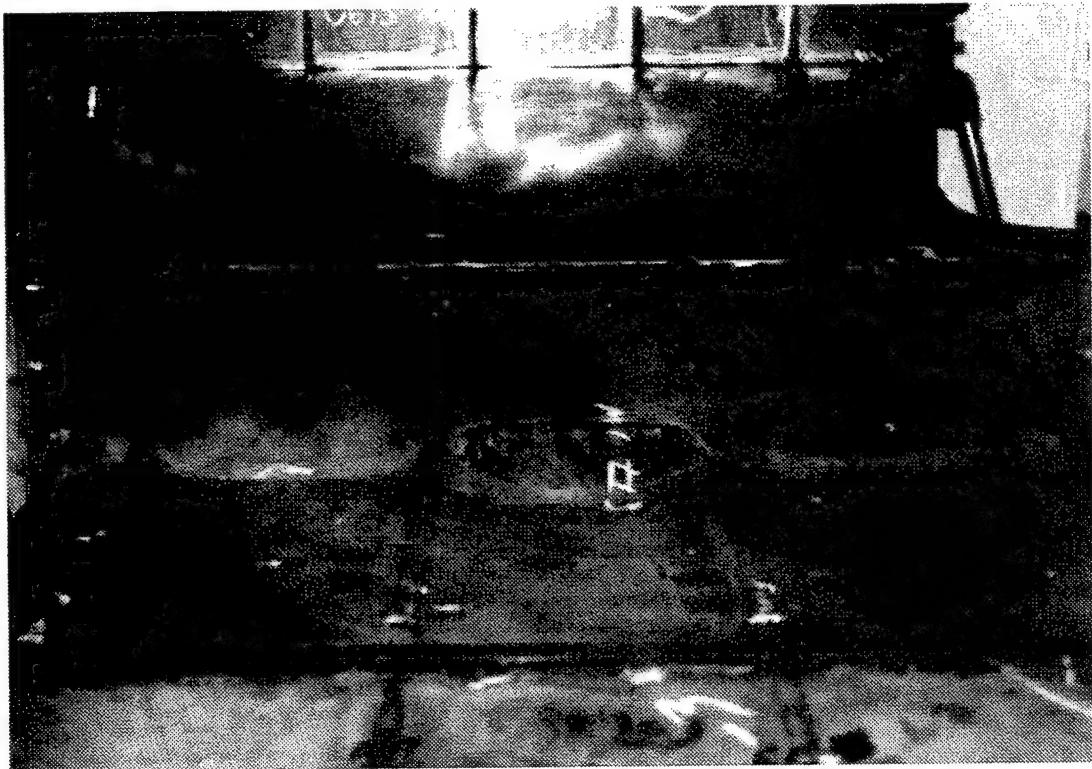
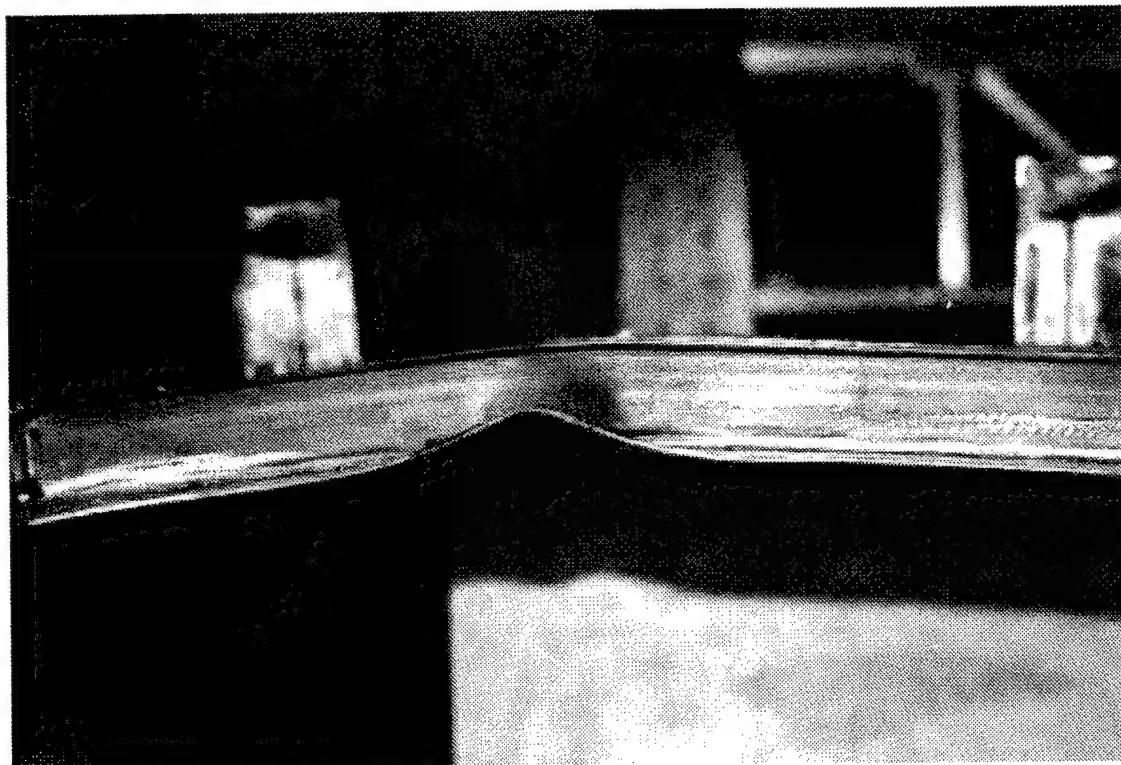
Grillage 0995 was loaded with a constant 20 psi of uniform lateral pressure. The ultimate collapse stress was 34,020 psi and the failure was by a Mode II mechanism. The uniform lateral pressure caused an initial deflection at the midspan of the inboard port stiffener of 0.014-inches and the inboard starboard stiffener of 0.028-inches. The initial deflection of the midspan of the center plate of 0.038-inches. The collapse started in the center panel of the center bay and proceeded outward to the stiffeners. Figure 38a shows the center bay of Grillage 0995 in the Test Fixture after collapse. Figure 38b shows the deformation experienced by the stiffeners and the plating. Figure 38c is a view of the deflection pattern on the plating side of Grillage 0995. Note how the pattern is the mirror image of that seen on Grillage 0695 (Figure 33c). The closeup view of the starboard stiffener in Figure 38d shows the amount of deflection experienced by the stiffener compared to that seen in the plate.

Figure 38a - Center Bay of Grillage 0995 in Test Fixture After Collapse

Figure 38b - Center Bay of Grillage 0995 Showing Stiffener and Plate Deformation

Figure 38c - Plate Deformations on Plating Side of Grillage 0995

Figure 38d - Detail of Plate & Stiffener in the Center Bay of Grillage 0995

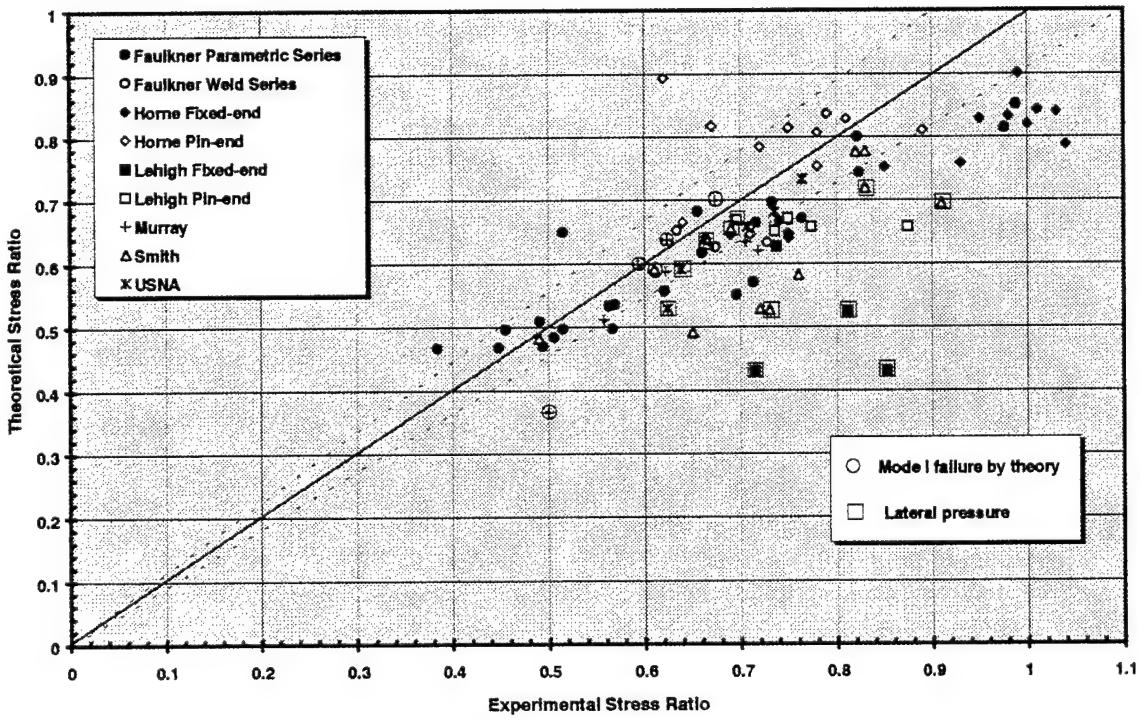
Figure 44 -Theory vs. Experiment for Test Database

Several important inferences can be made from Figure 44 regarding stiffened panel testing, the theoretical algorithm, and the effects of geometry on panel strength. Each test series points to one or more important issues about stiffened panel design and strength. The following discussion considers the relationships of boundary end conditions, combined axial and lateral loading, the theoretical algorithm, and panel geometry to Figure 44.

Horne^{7,8} conducted his series of tests using two approaches to boundary end conditions: one-half of his tests were fixed-end and the other half were pinned-end. The resulting relationships between these two procedures show that a pinned-end model is under conservative whereas a fixed-end model is over conservative. This conclusion agrees with reality, as the end boundary conditions of a panel in a ship's structure are neither entirely fixed nor pinned. Rather, an actual panel is somewhere between these two extremes; although it is not ideal either, a simply-supported end condition is used in the theoretical model for this very reason. Similarly, two series of tests were conducted at Lehigh University's Fritz Engineering Laboratory (Rampetstreiter et al¹⁰, Kondo and Ostapenko⁹), one fixed-end and one pinned-end. The delineation between these boundary conditions in Figure 44 is not distinct. However, this discrepancy should not discount Horne's results. Many of the Lehigh tests were subjected to combined lateral and axial loading. As discussed later in greater detail, the effect of lateral pressure on a stiffened plate tends to change the strength characteristics of a grillage.

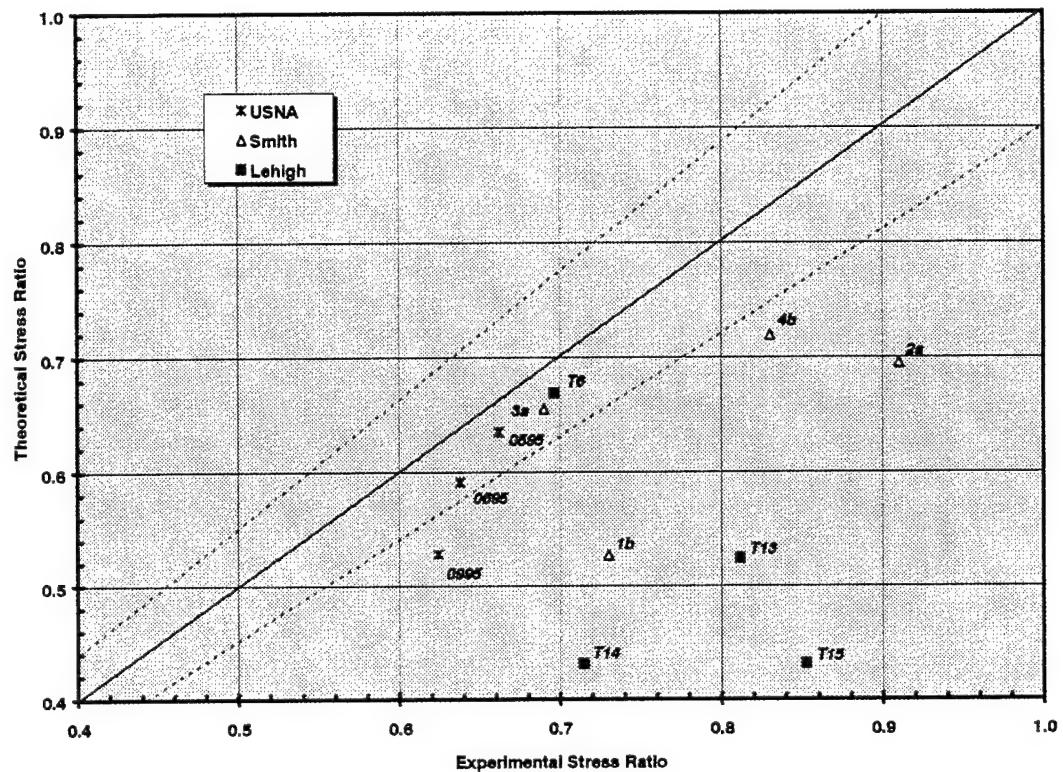
Figure 45 - Theory vs. Experiment for Combined Load Tests

Figure 45 provides some insight into this situation. As stated earlier, there are only eleven tests in the database which include lateral pressure with in-plane compression. The two data points from the Lehigh test series near the bottom of the chart (identified as *T14* and *T15*) were

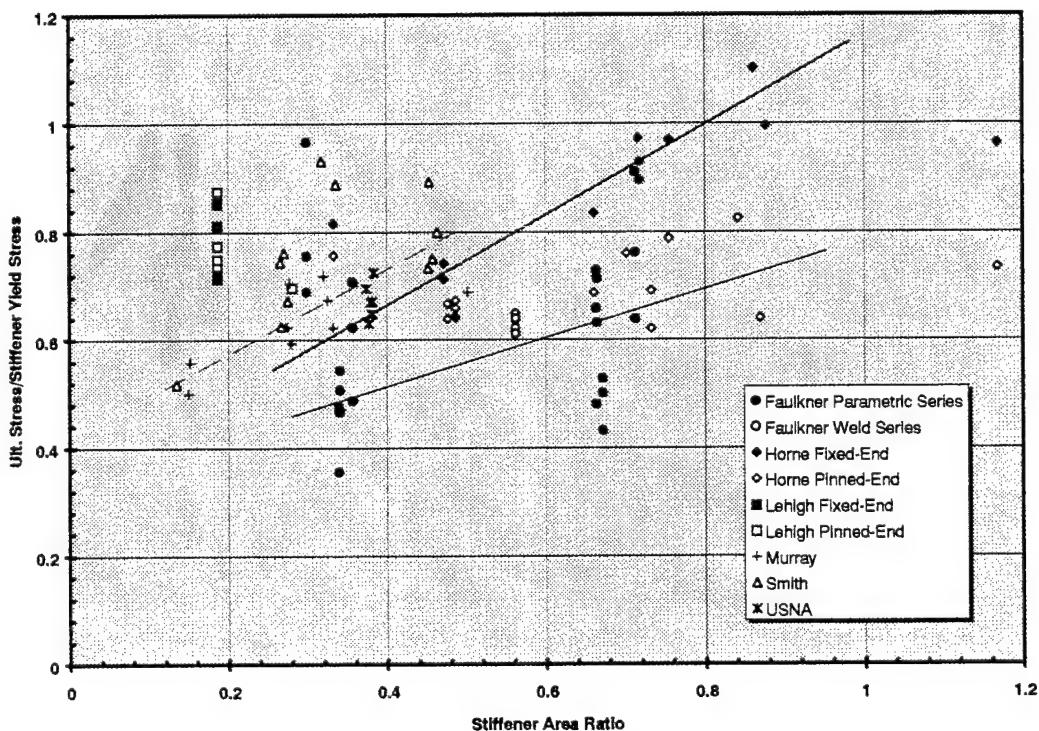
Figure 46 - Effect of Stiffener Area Ratio

Hughes et al⁵ found that the ultimate strength of longitudinally stiffened panels was most affected by the yield strength of the plating, the plating thickness, and the initial deflection of the plating. We concur with this finding but also feel that the ratio of the stiffener area to the plate area is an important parameter. If the plating is thick and the stiffener is small, the panel will fail near the yield strength of the plating. If the plating is thin and the stiffener is sturdy, the panel fails near the yield strength of the stiffener. Figure 46 attempts to show this effect. The lines drawn in Figure 46 are intended to show the general trend of the data for different groups. Because so many other parameters have an effect on the ultimate strength, there is a lot of scatter. However, we believe that the trend is exhibited in the figure.

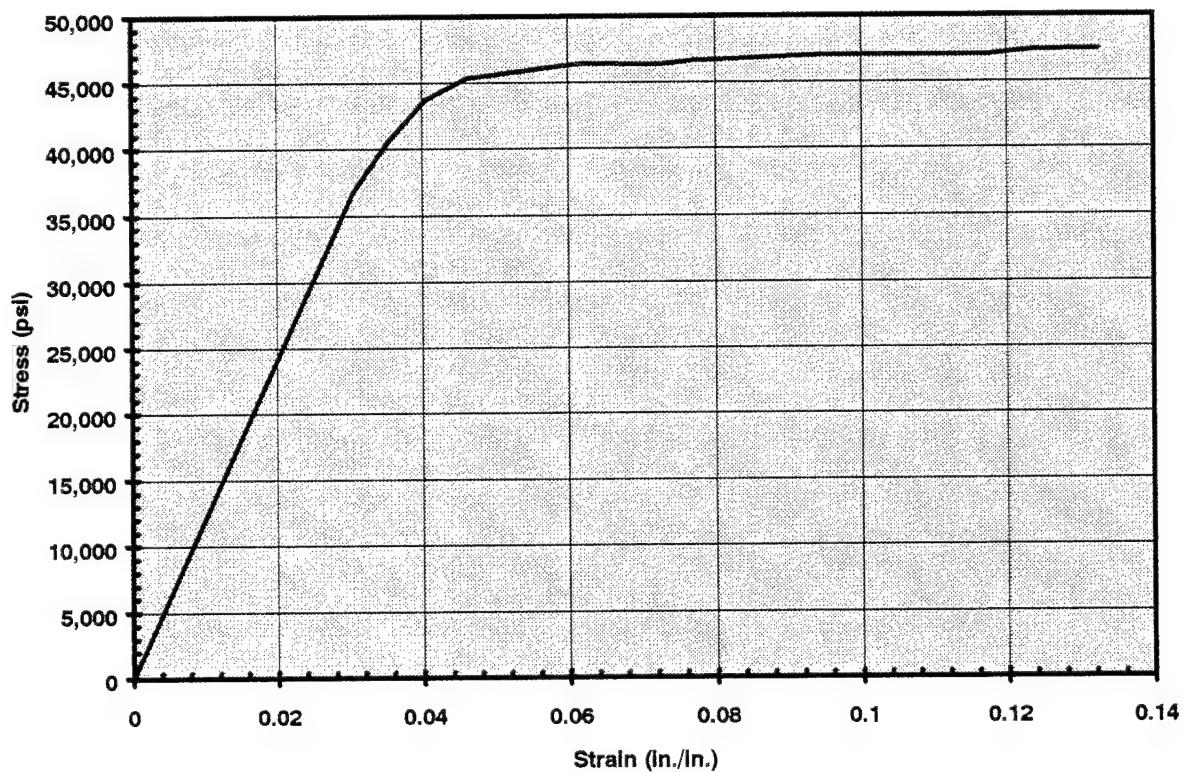
Figure 48-Compressive Coupon Test for Center Plate

Elastic material properties were defined to be equal to the nominal values for mild steel: Young's modulus, $E = 30,000,000$ psi and Poisson's ratio, $\nu = 0.3$. Material properties in the plastic region were determined from compression coupon tests performed at NSWC. These tests showed that mild steel displays an almost perfectly elastic-plastic behavior under compression. Figure 48 shows a plot of the results for the coupon test of the plating used in the center bay of the grillage.

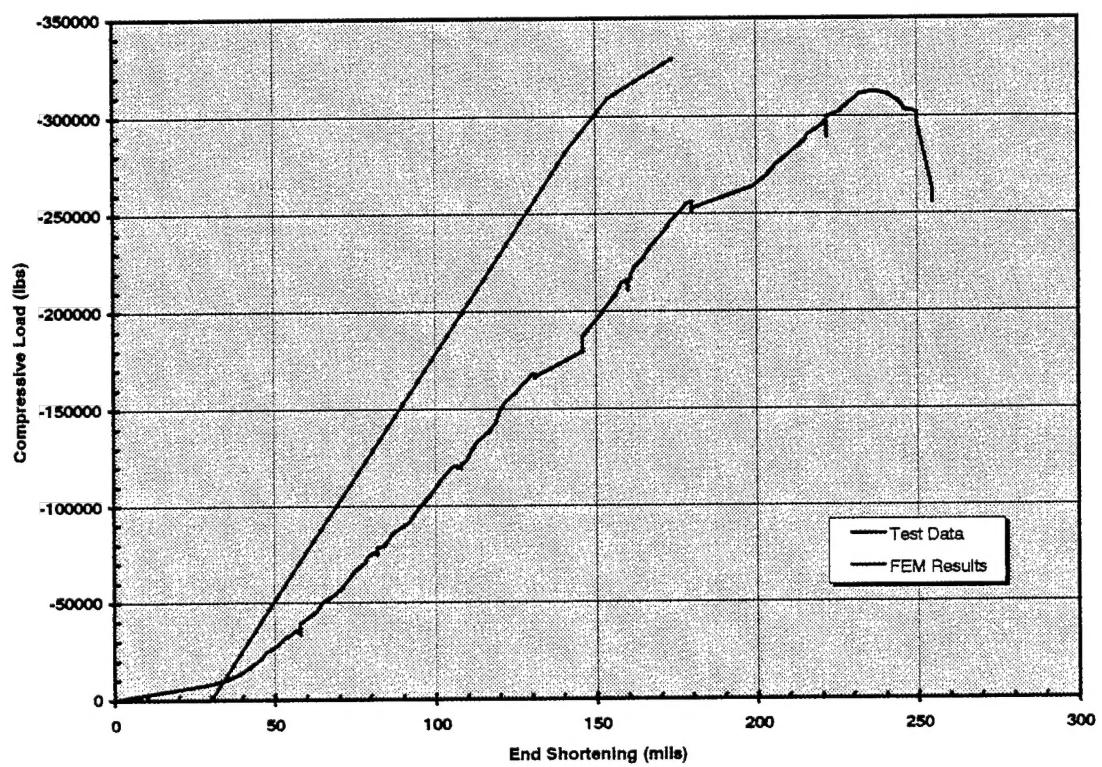
Figure 51 Comparison of FEA and Grillage Test Results

In general, the FEA analysis tended to give displacements which were smaller than those observed during the testing. A comparison of the load versus end-shortening results for the FEA run and Grillage 1094 is shown in Figure 51. The FEA load versus end-shortening plot is based on longitudinal displacements between nodes 18 and 294. The total load from the FEA is found to be 329,354 lbs when the solution fails at an end-shortening of 0.144 inches. The data for Grillage 1094 were developed from the string potentiometers used to measure end-shortening. Later experience with the string potentiometers and other measuring devices has caused us to discontinue using the string potentiometers in this application. The level of non-linearity in the string potentiometers is unacceptable and accounts for some of the difference in slope between the FEA and Grillage 1094 seen in Figure 51. It should be noted that the average ultimate load of the three in-plane load only grillage tests (0494, 0894, & 1094) was 313,027 lbs. This represents a difference of about 5.2% from the FEA results, well within acceptable tolerances for FEA.

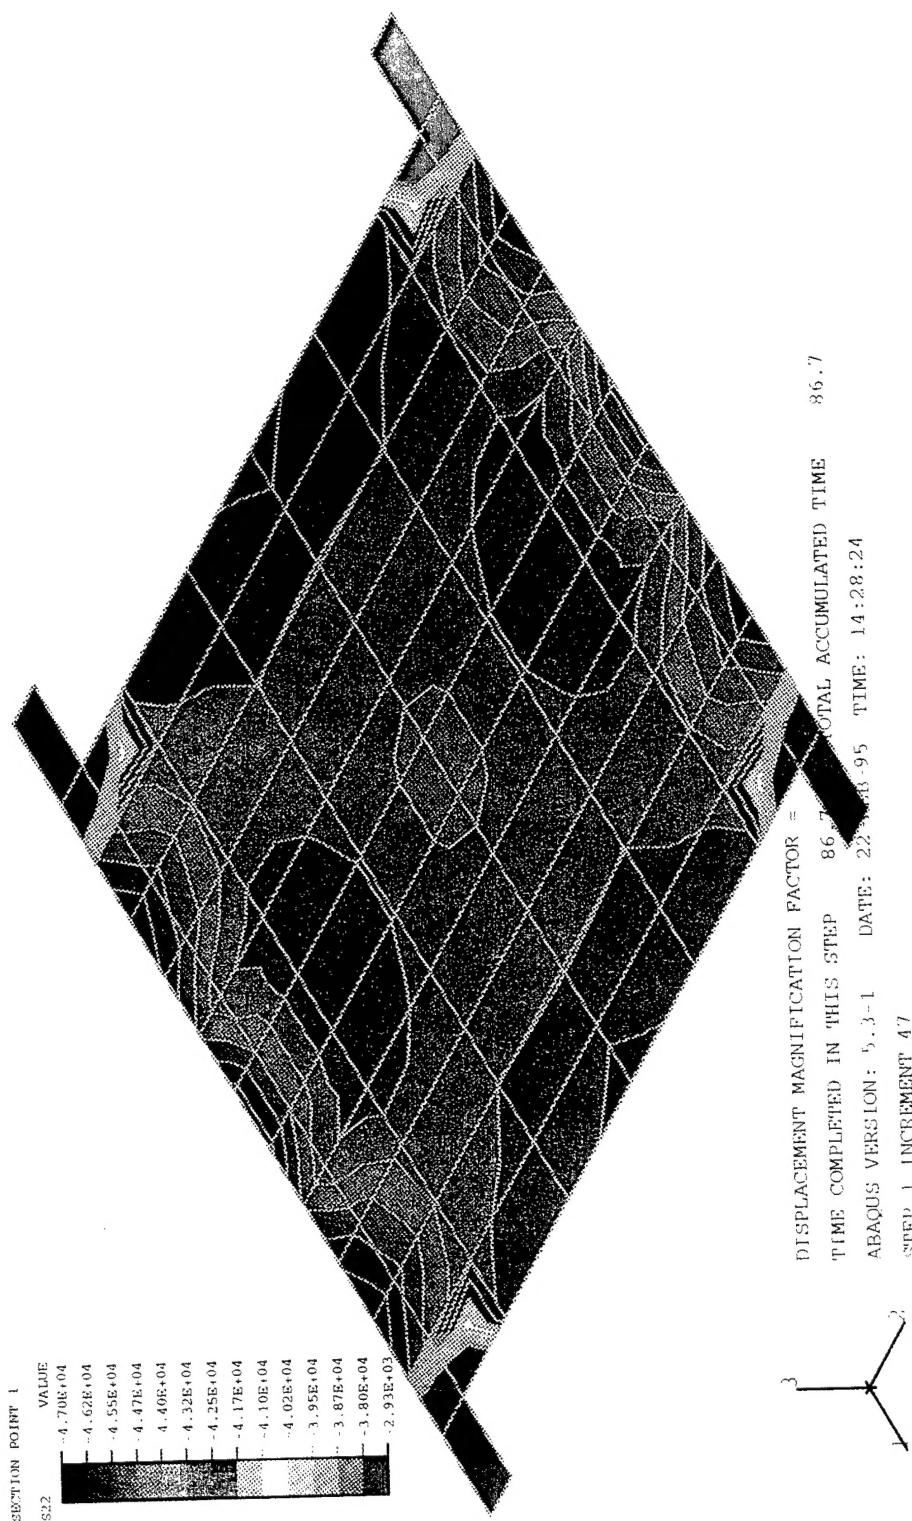
Figure 52 - Contour Plot of Stresses in Center Bay

Figure 52 is a contour plot of the FEA-based stresses in the center plate under peak loads. The maximum stresses in the center plate are about 47,000 psi and are located at the connections
